**SYSTEMATIC INVESTIGATION OF FAILURE ANALYSIS ON A STEAM  
TRAP BYPASS TUBE IN A COALFIRED POWER PLANT**

A project report submitted in partial fulfillment of the requirements for the award of  
Masters Degree in Mechanical Engineering

Faculty of Mechanical and Manufacturing  
Tun Hussein Onn University of Malaysia

NOVEMBER 2007

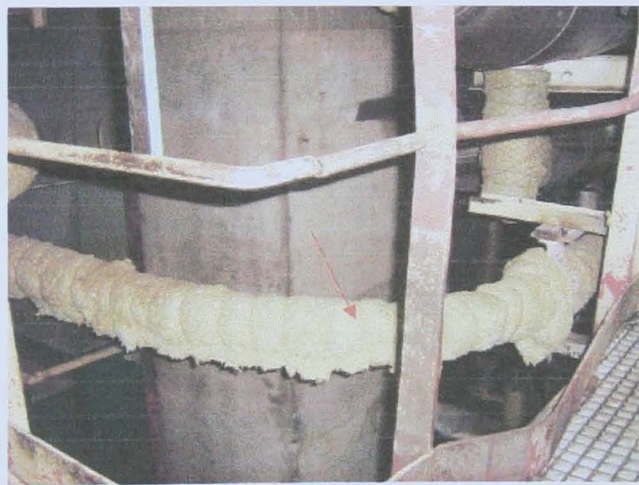
**Figure 1.1:** Insulated steam trap bypass tube in actual process.

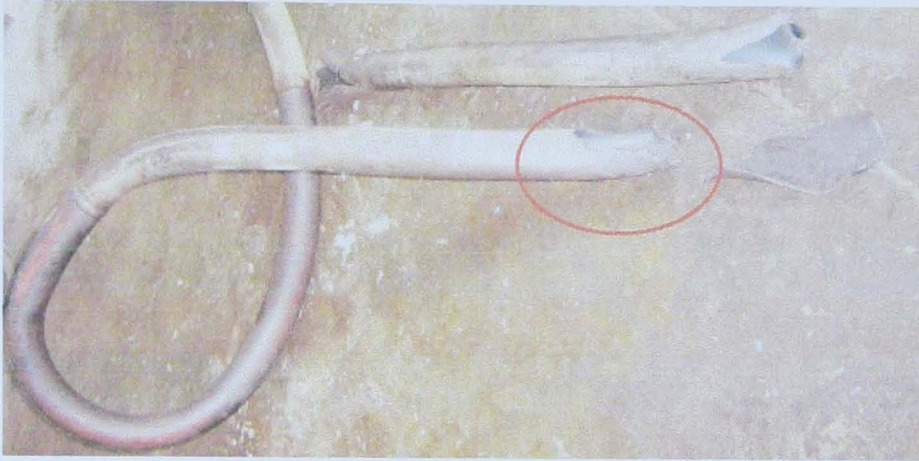
**Figure 1.2:** Fractured steam trap bypass tube (in circle indicates picture of sample received).
