Detection of mainland Kedah's shoreline changes (2013-2020); a case study

To cite this article: W M Wan-Afnizan *et al* 2024 *IOP Conf. Ser.: Earth Environ. Sci.* **1347** 012017

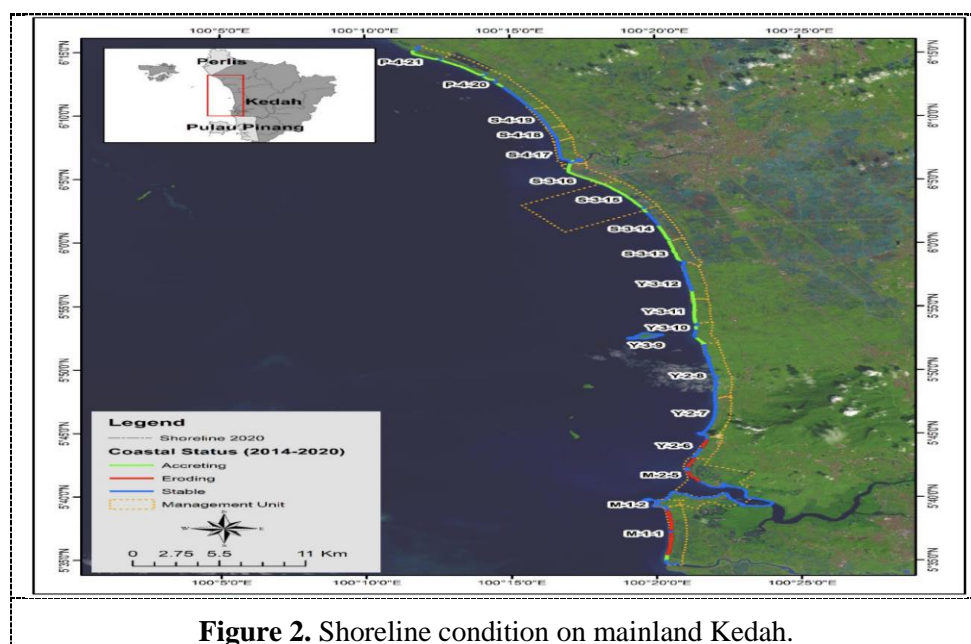
Figure 2. Shoreline condition on mainland Kedah.

As previously mentioned, the investigated shoreline condition was classified into three different zones namely, stable, accreting, and eroding zones. Figure 2 shows the general overview of the shoreline condition of mainland Kedah at which the blue line represents the stable zones, while the green and red lines represent the accreting and eroding zones, respectively.

The shoreline condition was assessed based on the collected images between the years 2013 and 2020. Overall, it can be seen that the mainland Kedah shoreline did not experience extensive erosion at which only 10.1 km suffered from erosion issues. This was due to the major enhancements along Kedah's shoreline by constructing rock revetment and rip raps to protect the coastal area. On the other hand, shoreline accretion was found to cover a longer stretch of the shoreline with a total length of 40.1 km. The remaining length of the shoreline Kedah's shoreline was found to be stable, the stable stretch covers 58.8 km of the shoreline's total length. According to the obtained results, a total of 6 stretches were observed to suffer from erosion along Kedah's shoreline with the highest rate of 27.3 m/year in MU M-2-5 (Pantai Rhu to Kg. Huma). On the other hand, a total of 19 stretches were found to suffer from accretion, where the highest average accretion rate was found to be 23.6 m/year in the vicinity of Kampung Sala (MU P-4-21). When comparing the present study findings with the National Coastal

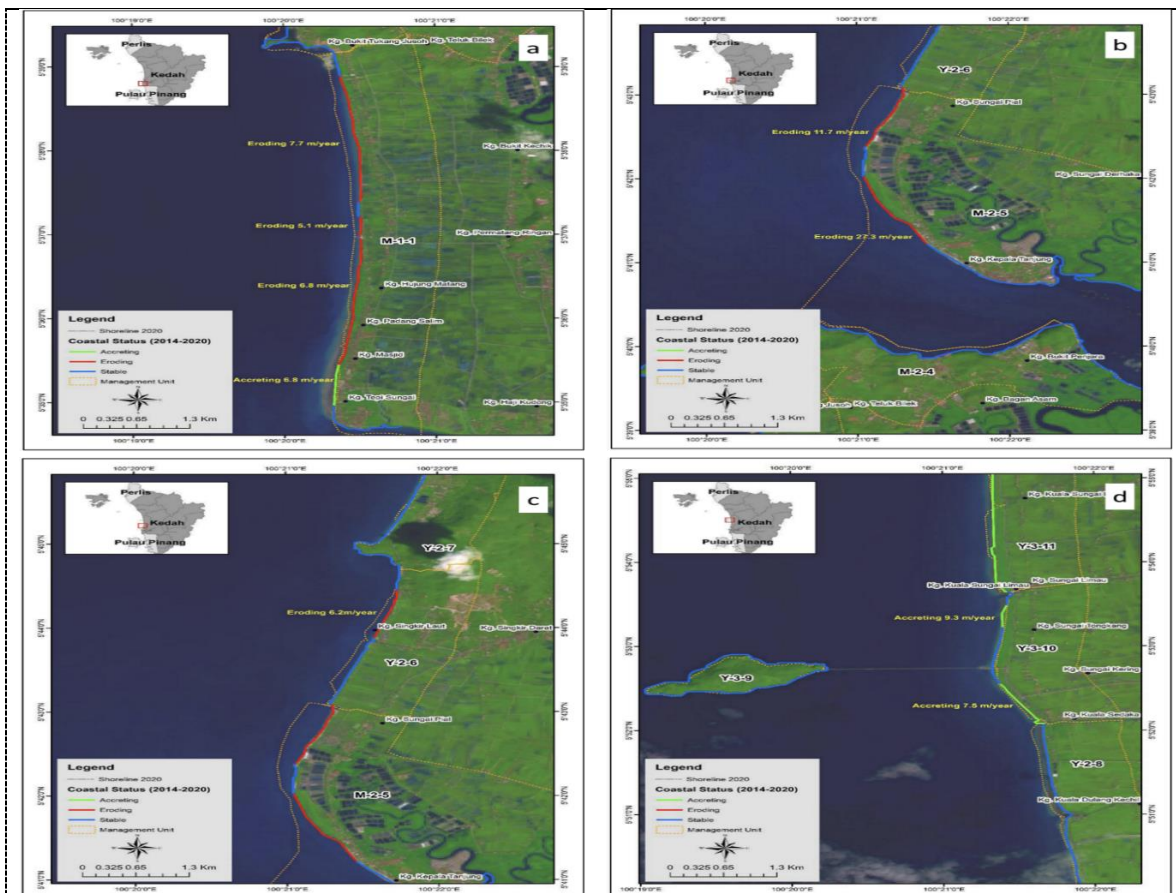
Figure 3. Shoreline conditions (a) MU M-1-1, (b) MU M-2-5, (c) MU Y-2-6, and (d) MU Y-3-10.

Along the shoreline of MU M-1-1, shoreline accretion was observed along the stretch between Kg. Tepi Sungai south and Kg. Kepala Jalan north (around 0.9 km) with a yearly rate of 6.8 m/year as shown in Figure 3a. The mangrove vegetation was noticed to be repropagated fronting the coastal bund. On the other hand, shoreline erosion was observed in three locations which include (i) 2.8 km from Kg. Masjid to Kg. Paya with an erosion rate of 6.8 m/year, (ii) 0.4 km in Kg. Paya with an erosion rate of 5.1 m/year, and (iii) 2.7 km from Kg. Meriam to Kg. Yu with an erosion rate of 7.7 m/yea. The mangrove vegetation was noticed to be die-backed along the eroded shoreline.

Along the shoreline of MU M-2-5, no accretion was observed along the whole stretch. However, shoreline erosion was noticed in 2 locations which include (i) 1.7 km between Pantai Rhu and Kg. Huma with erosion rate of 27.3 m/year, and (ii) 1.4 km between Kg. Sg Pial to Teluk Sungai with erosion rate of 11.7 m/year as shown in Figure 3b. The groynes that were present near Tanjung Dawai in 2003 were not detected in 2017 along with the receding sandy shoreline. The mangroves along the rest eroded shoreline have either thinned significantly or are non-existent.

In Y-2-6 management unit, shoreline erosion was observed only in one location with a total length of about 1.1 km, while there are no eroded locations. The eroded location was extended between m Kg.

Singkir to Jln. Pantai Barat Kedah as shown in Figure 3c. The average yearly erosion rate was found to be 6.2 m/year. The width of the mangrove belt fronting the coastal bund was significantly affected.

Along the shoreline of Y-3-10 management unit, two locations were observed to suffer from erosion which include, (i) 1.1 km from Kg. Kuala Dulang Kechil to Kg. Sungai Kering with erosion rate of 7.5 m/year, and (ii) 0.5 km in Kg. Sungai Tongkang with an erosion rate of 9.3 m/year as shown in Figure 3d.

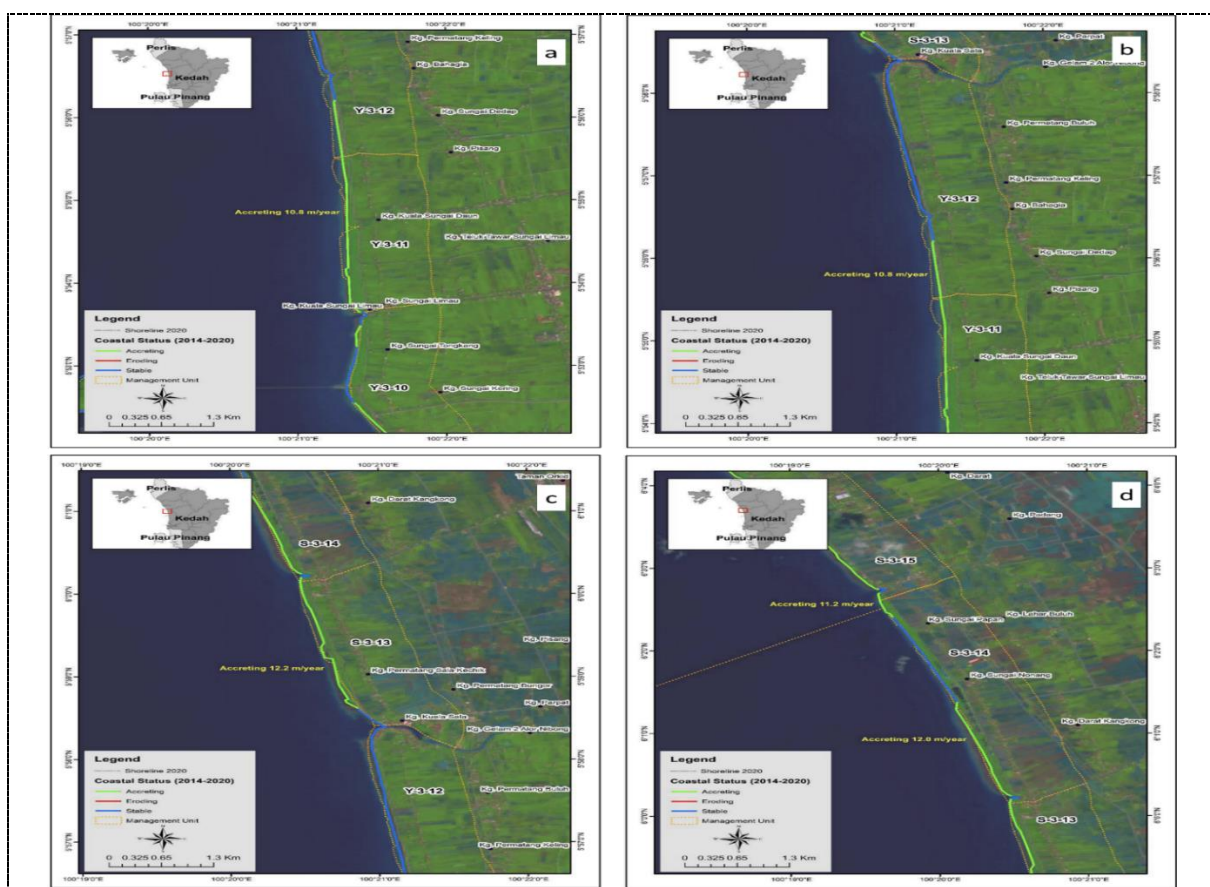
Figure 4. Shoreline conditions (a) MU Y-3-11, (b) MU Y-3-12, (c) MU S-3-13, and (d) MU S-3-14.

The whole shoreline stretch along Y-3-11 management was noticed to suffer from accretion starting from Kg. Sungai Limau and ending by Kg. Sungai as shown in Figure 4a. The total length of this MU is about 4.9 km and the accretion rate was found to be around 10.8 m/year. The mangrove vegetation was noticed to be repopulated on the seaward frontage of the shoreline.

In this management unit, shoreline erosion was not observed, while only one location was noticed to suffer from accretion which is located to the north of MU Y-3-11 as shown in Figure 4b. The total length of the affected area is around 1.3km and the rate of accretion was about 10.8 m/year. Similar to MU Y-3-11, The mangrove vegetation was noticed to be repopulated on the seaward frontage of the shoreline.

Most of the shoreline of MU S-3-13 was noticed to be suffering from accretion with an average yearly rate of 12.2 m/year. The total length that was affected was about 3.2 km which represents more the 90% of the MU shoreline length. The shoreline accretion was exactly observed between Kg. Kuala Sala to Kg. Kuala Kangkong as shown in Figure 4c.

Accretion was observed at two locations, on the north and south sides of the MU, while the middle part was noticed to be stable as shown in Figure 4d. The affected locations were (i) the vicinity of Jalan Kuala Sala with a total length of 2.2 km and average accretion rate of 12.0 m/year, and (ii) the shoreline stretch between Kg. Sungai Papan and Kg. Laharat Pumpong with a total length of 0.6 km and an average accretion rate of 11.2 m/year.

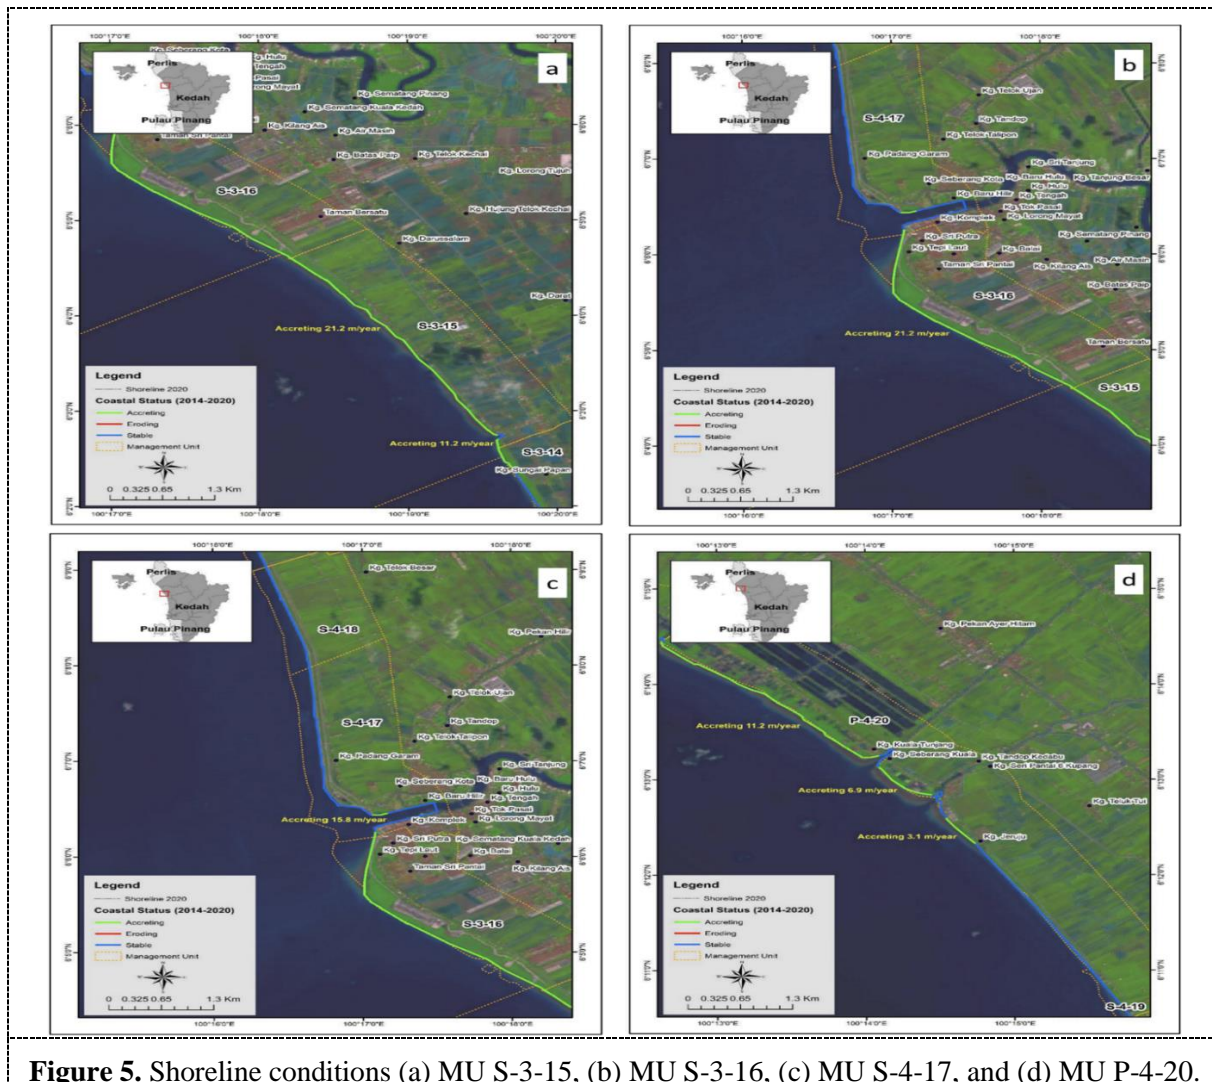
Figure 5. Shoreline conditions (a) MU S-3-15, (b) MU S-3-16, (c) MU S-4-17, and (d) MU P-4-20.

Figure 5a shows the shoreline condition along the S-3-15 management unit. It can be seen that almost the whole shoreline stretch was suffering from accretion. The largest accretion area was located at the north side of the MU with a total affected length of 8.5 km (from Kg. Lahar Pumpong to Kg. Sri Putra) with an average accretion rate of 21.3 m/year. A small area located at the south side of the MU with a total length of 0.4 km was accreting as well and the average accretion rate was found to be 11.2 m/year as shown in Figure 5a.

Figure 5b shows the shoreline condition along the S-3-16 management unit. According to the presented figure, it can be clearly seen that the whole stretch of this MU is suffering from accretion. The total length of the shoreline is about 8.5 km, and the average rate of accretion was found to be 21.2 m/year.

Along the shoreline of the S-4-17 management unit, only a short stretch was noticed to be suffered from accretion with a total length of 0.2 km near Jalan Marina Harbour. The average yearly accretion rate was found to be around 15.8 m/year. The accretion in this location was specifically due to the regeneration of mangroves within the abandoned Kuala Kedah marina. The rest length of the shoreline in this MU was found to be stable and no erosion was noticed as shown in Figure 5c.

Three locations were observed to suffer from accretion along the shoreline of this MU which include, (i) 0.6 km in the vicinity of Kg. Jeruju with an average accretion rate of 3.1 m/year, (ii) 0.9 km in the vicinity of Jalan Seberang Kuala with an average accretion rate of 6.9 m/year, and (iii) 3.6 km from Kg. Kuala Tunjang to Jalan Kampung Baru Tepi Laut with average accretion rate of 11.2 m/year as shown in Figure 5d.
