**FAILURE ANALYSIS OF CONVEYOR CHAIN LINKS: A CASE STUDY
AT TOP GLOVE SDN. BHD.**

NUR ISMALINA BINTI HARIS

A project report is submitted as partial fulfillment of the requirements for
the award of the degree of
Master of Mechanical Engineering

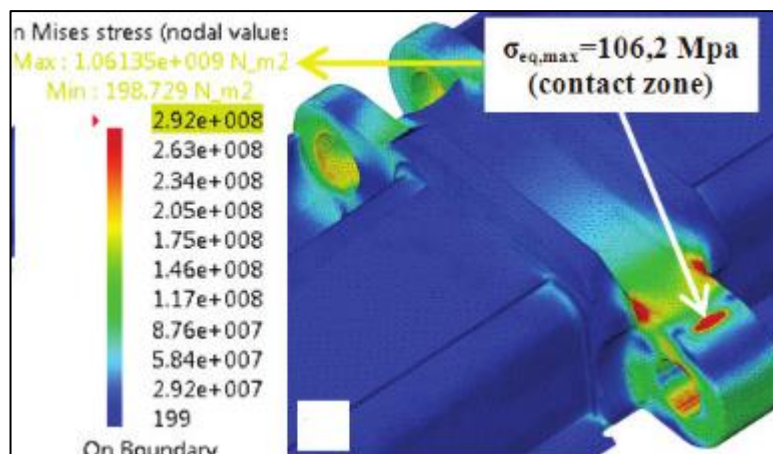
Figure 3.4: Stresses zone in the chain link (Bošnjak, Arsic, Nenad, Odanovic, & Dordevic, 2011)

Bošnjak S. et. al. (2011) added his investigation by using finite element method (FEM) to find working stresses in the chain link. Referring to Figure 3.4, he found that the critical zone or fractures zone was around the chain link.

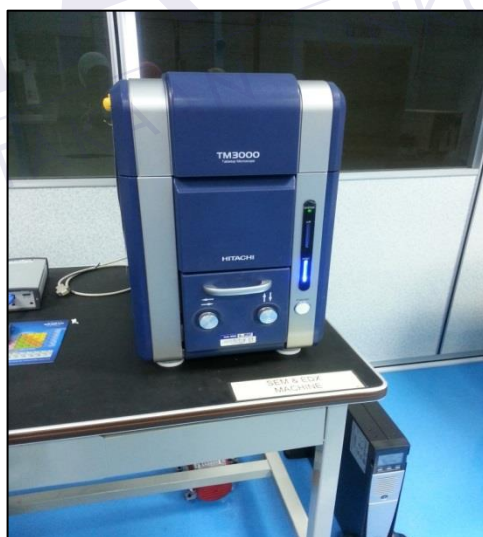
Figure 4.3: SEM with EDX: TM3000 Hitachi at *UniMAP*

So, one of the most important instruments used to carry out failure analysis is Scanning Electron Microscope or commonly known as SEM. SEM is a type of electron microscope that images the sample surface by scanning it with a high-energy beam of electrons in a raster scan pattern and belongs to the non-destructive test.

The electrons interact with the atoms that make up the sample producing signals that contain information about the sample's surface topography, composition and other properties (Shamsudin, 2011). SEM magnification can be control over a range up of to 6 orders from 19x to 300,000x. SEM also can achieve resolution better than 1 nanometre. And the important of SEM in failure analysis is due to its ability to provide three-dimensional image for the purpose of fractographic study where the depth of field is needed on an irregular fracture surface (De Carvalho, 2003). In this investigation, scanning electron microscopy (SEM with EDX: TM3000 Hitachi) as shown in Figure 4.3 will be used to reveal the fracture surface topography at high magnification.
