**SYSTEMATIC INVESTIGATION OF FAILURE ANALYSIS ON A STEAM  
TRAP BYPASS TUBE IN A COALFIRED POWER PLANT**

A project report submitted in partial fulfillment of the requirements for the award of  
Masters Degree in Mechanical Engineering

Faculty of Mechanical and Manufacturing  
Tun Hussein Onn University of Malaysia

NOVEMBER 2007

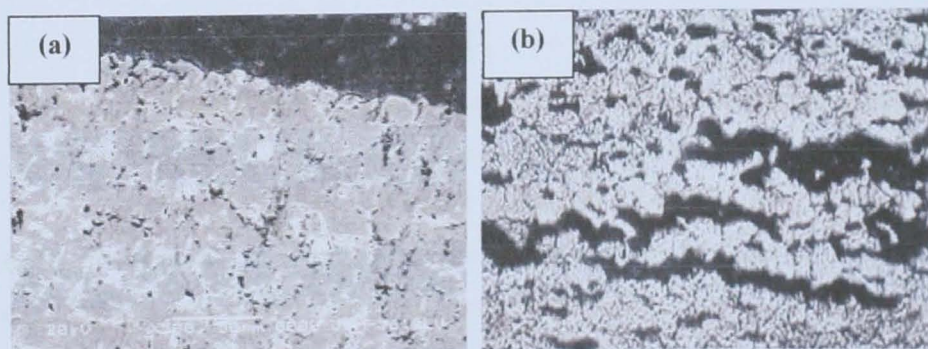
**Figure 2.1:** (a) Inter-granular cracks and presence of numerous creep cavities at grain boundary (b) Inter-granular nature of propagation with many small parallel cracks.

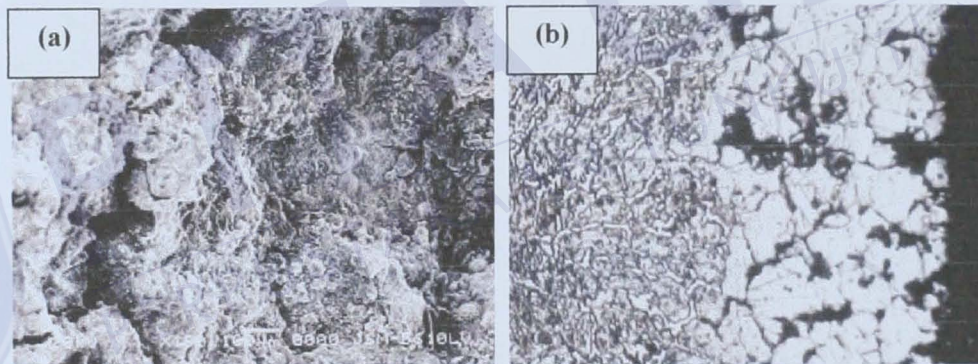
Failure investigation was also done on a furnace tube failure [25]. The failure occurred in a bottom fired furnace tube with experienced service of 14 months against the normal life of 6 to 7 years. The tube is 25 Cr/35 Ni. The average tube metal temperature remains between 1000°C to 1100°C temperatures. As per the manufacturer data, these tubes are designed for 1150°C. The pressure inside the tube is 1 kg/cm<sup>2</sup>. SEM analysis conducted revealed a progressive nature of fracture especially towards OD side shown in figure 2.2 (a). However, majority evidences on fracture surface were masked under heavy scaling, which is generally expected under such service. From microstructure examination (figure 2.2 (b)), the crack is associated with carburizing more so at outer surface with decreasing the depth of carburizing towards ID which is another important evidence of crack originating from outer diameter and progressing towards ID. This magnification was done using a Leco Image Analyser at 300X. In present case the failure of tube has occurred due to localized overheating, which reduced ductility and failed under operational vibrations.

**Figure 2.2:** (a) Progressive nature of fracture (b) Crack is associated with carburizing more at outer surface.

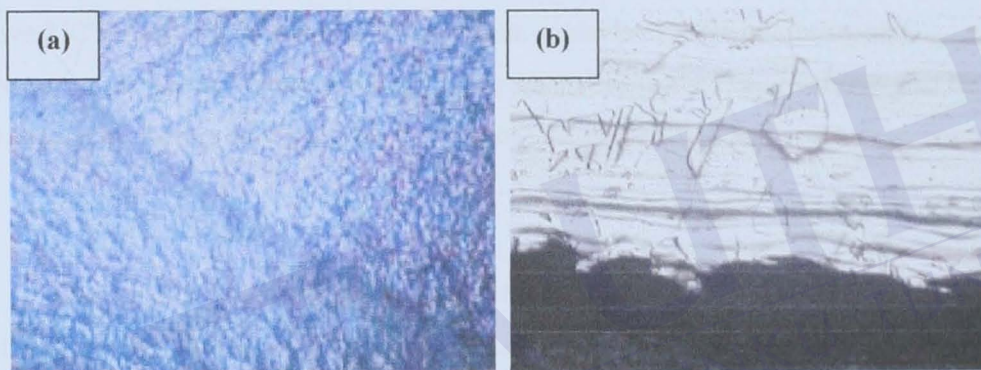
2% H<sub>2</sub>SO<sub>4</sub>, 0.5% HNO<sub>2</sub> and 0.6 to 1.0 % HNO<sub>3</sub> at 10 to 20°C temperatures. Low magnification examination was done by the failure Analysis and Investigation team to find out the corrosion characteristics. Internal surface of pipe, weld and elbow showed severe corrosion on pipe. The close-up view of corroded surface inside the pipe showed effect of general corrosion and flow pattern (figure 2.3 (a)). Leakages observed in the form of openings between weld and pipe. From microstructure examination, uniform dissolution at ID is observed under microstructure examination at a magnification of 300X as shown in figure 2.3 (b). The fluctuation in nitric acid concentration did not allow stabilizing passivity on newly fabricated pipeline resulted into severe corrosion.

**Figure 2.3:** (a) Effect of general corrosion and flow pattern  
(b) Uniform dissolution at ID.
