FAILURE ANALYSIS OF A SUPERHEATER  
TUBE OF A COAL-FIRED POWER PLANT

SALUSTIANO DOS REIS PIEDADE

UNIVERSITI TUN HUSSEIN ONN MALAYSIA

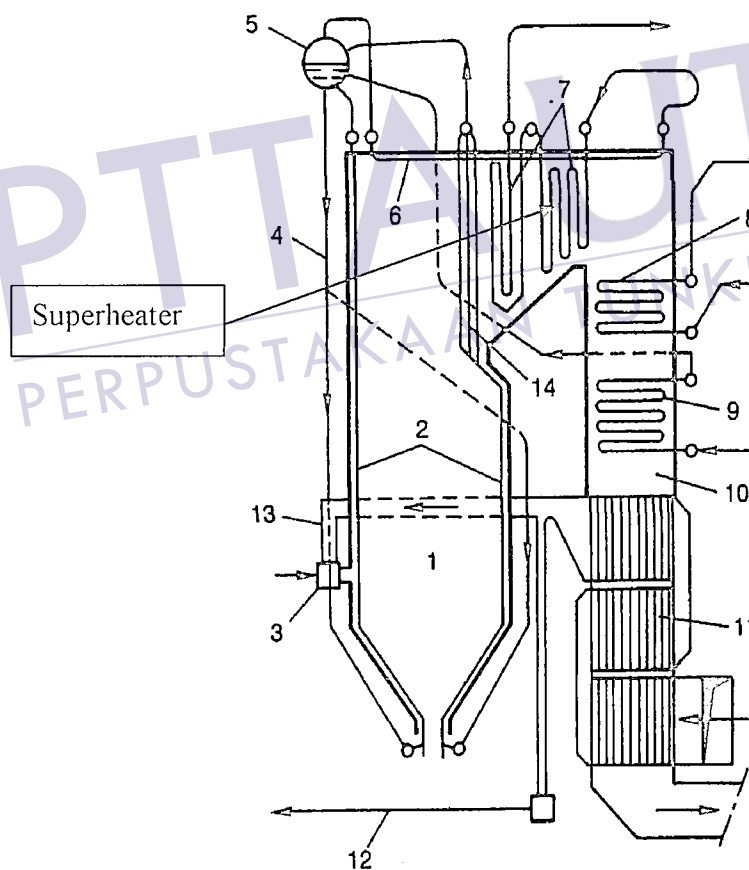
**Figure 2.1:** Flow diagram of the natural –circulation boiler: 1-furnace, 2-water wall, 3-burners, 4-downcomers, 5-drum, 6-radiant superheater, 7-convection superheater, 8-reheaters, 9-economizer, 10-gas duct, 11-air heater, 12-primary air, 13-secondary air [2].

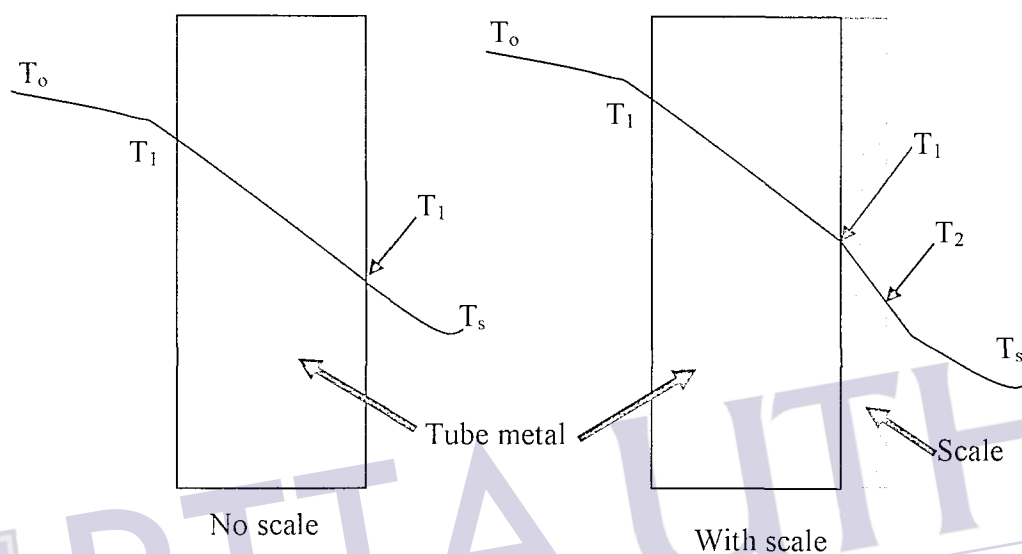
**Figure 2.2:** The temperature profile from flue gas temperature ( $T_0$ ) to steam/water temperature ( $T_s$ ) for the clean tube and the scaled conditions.

overheating can result in burned-out tubes and blisters on steam and water drums. Figure 2.2 illustrates the formation of deposit layer of the tube of water/steam surface, where;  $T_0$  is temperature of flue gas,  $T_1$  is temperature of tube metal,  $T_2$  is temperature of oxide scale and  $T_s$  is temperature of steam.

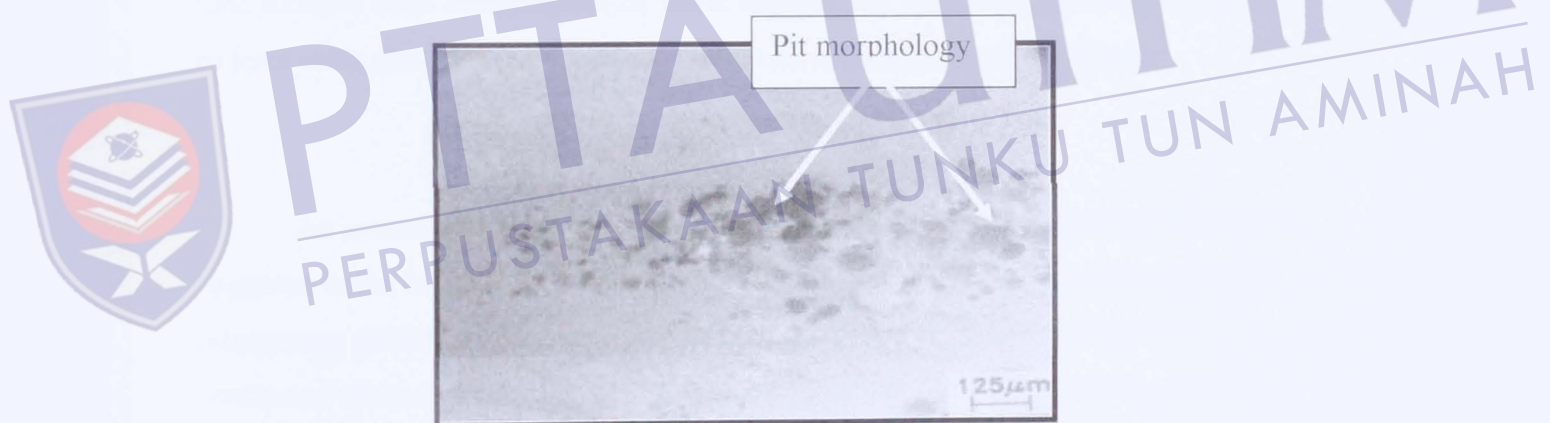
**Figure 2.3:** SEM micrographs showing pit morphology [22].

Pitting corrosion is form of extremely localized attack that results in holes in the metal (Figure 2.3). These holes maybe small or large in diameter, but in most

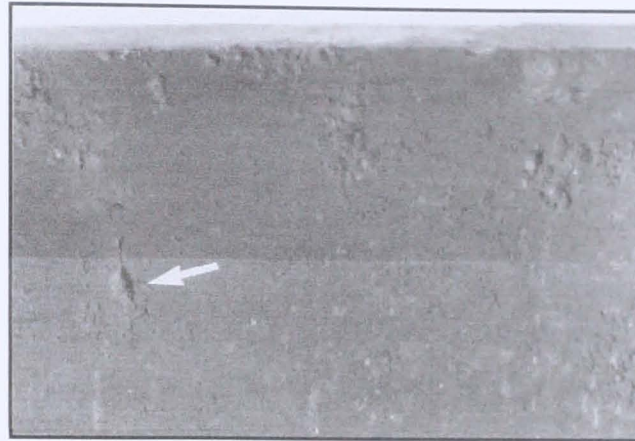
**Figure 2.4:** Close up view of crack (arrowed) and pitting at the point of minor leakage [23].

An investigation was carried out by Heyes [23] on oxygen pitting failure of a baggasse boiler tube. This investigation the optic microscope and scanning electron microscopy (SEM) with an energy dispersive X-ray spectroscopy was used to conducted microstructural study of metals. He reported that the pitting observed in the tube was a result of oxygen pitting (Figure 2.4) and probably occurred during the wet storage period due to inadequate maintenance of the water levels, pH and the amount of oxygen scavenger.

During wet storage the boiler should have been kept completely filled with water (to exclude air) or nitrogen copped, the pH maintained around 11 and the water dosed with sodium sulfite to a residual level of at least 100 ppm. The most likely cause of the cracking observed in the tube is vibrations caused by harmonic oscillation. Obviously, the vibrations must be minimized or eliminated, if possible.

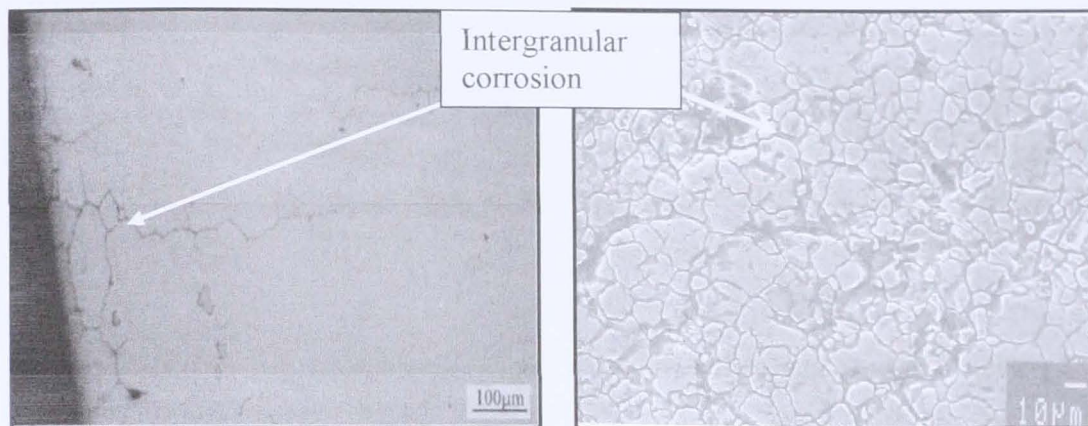
**Figure 2.5:** Intergranular corrosion crack and early intergranular corrosion fatigue [21, 25].

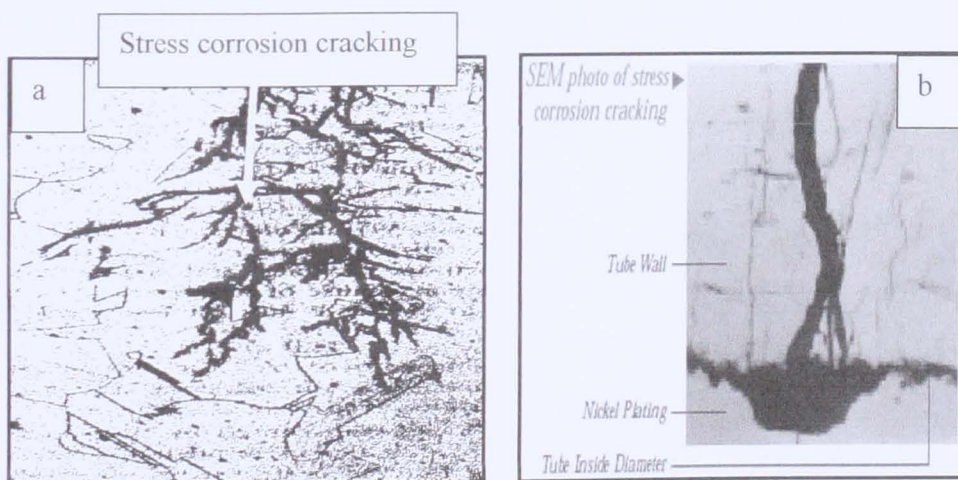
**Figure 2.6:** SEM micrograph of stress corrosion cracking [26, 27, 28].

Stress corrosion cracking is the result from the simultaneous action of residual or applied tensile stress and chemical action by a corrosive environment. Stress corrosion cracking manifests itself as a crack in the metal not necessarily accompanied by corrosion showing in Figure 2.6. This simultaneous influence of

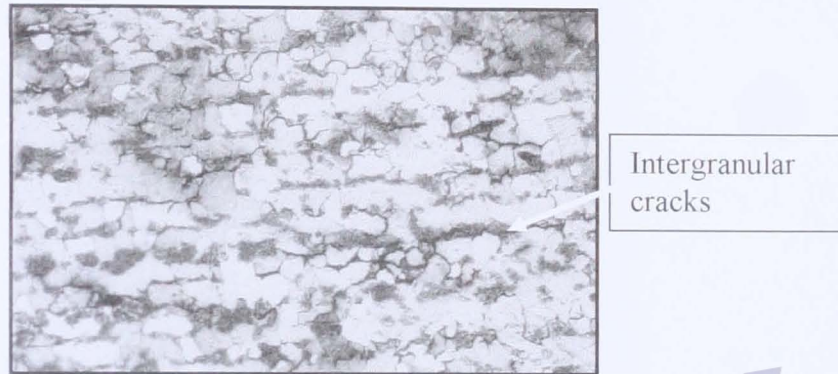
**Figure 2.7:** Microstructure of the cross section at the failed zone towards the waterside surface. The structure reveals ferrite + pearlite and intergranular cracks [29].

Srikanth et al. [29] has done experimental investigation on phosphate induced stress corrosion cracking in water wall tube from a coal fired boiler. The failure of a water wall tube in a coal-fired boiler from a thermal power station was analyzed. In this investigation the microscope optic (MO), scanning electron microscopy (SEM) with an energy dispersive X-ray spectroscopy (EDS) and energy dispersive X-ray diffraction was used to study the microstructural of metals.

They reported that the failure in the water wall tube initiated locally at the waterside surface because of caustic corrosion. The corrosive environment appears to be related to the presence of excess amounts of sodium phosphates in the feed water. Figure 2.7 showed the subsequent failure of the tube has occurred by phosphate induced intergranular stress corrosion cracking.

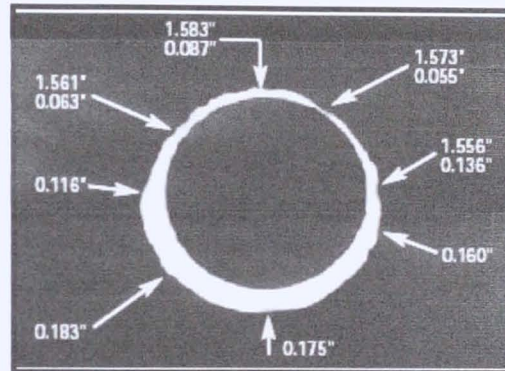
**Figure 2.8:** Sectional photo of tube with severe wall loss from fireside ash corrosion [28].

establishing the size, geometry and materials used in the boiler. Combustion gas and metal temperatures in the convection passes are important considerations. Damage occurs when certain coal ash constituents remain in a molten state on the superheater tube surfaces. Symptoms; External tube wall loss and increasing tube strain. Tubes commonly have a pock-marked appearance when scale and corrosion products are removed (see Figure 2.8).

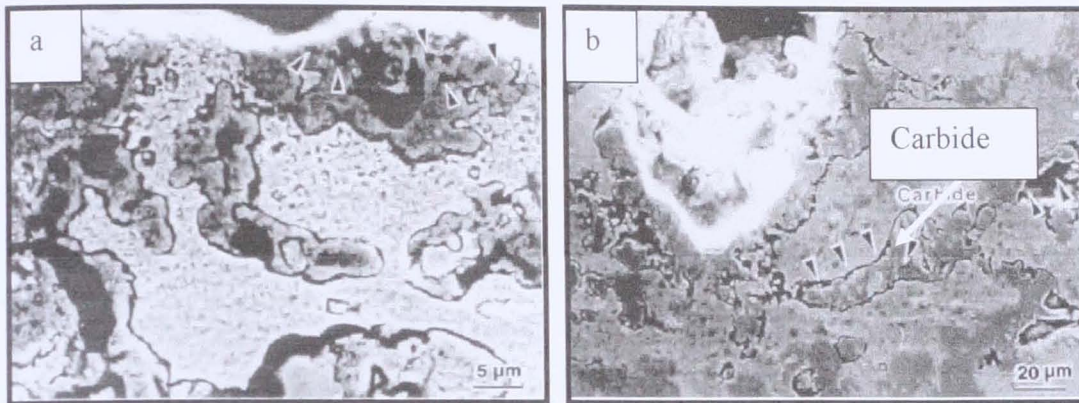
**Figure 2.9:** (a) SEM image of failed tube illustrating voids in the surface oxide scale indicated by the arrows and (b) SEM image of failed tube at the sagged region illustrating large density of voids at grain boundaries [32].

An investigation was carried out by Anwar et al. [32] on failure analysis of furnace radiant tubes exposed to excessive temperature. In their investigation, the microstructural features were characterized using scanning electron microscopy (SEM). Energy dispersive X-ray spectroscopy (EDS) combined with SEM was used to determine the chemical composition. They reported that most evidence pointed out that the cause of failure was due to exposure to an excessively high temperature likely during decoking. Exposure to an excessively high temperature could have two detrimental effects. First, the creep rate was accelerated leading to the formation of grain boundary voids as observed (Figure 2.9). Service experience indicated that the life of a radiant furnace tube made of cast HK 40 stainless steel was reduced by as much as 90% when the service temperature was raised by only  $56^\circ\text{C}$  above the prescribed temperature. Creep deformation can lead to cracking of the protective oxide scale causing an accelerated carburization attack. Secondly, a higher temperature accelerated the rate of carburization attack as pointed out earlier.

However, it is very likely that the effect of creep was compounded by presence of a continuous network of grain boundary carbide due to carburization. Rapid cooling from a temperature near the melting point maintains a high concentration of C in super-saturation. To promote creep strength, the carbides must be in the form of fine dispersion in the austenite matrix which can be achieved by exposure to a relatively low temperature. However, as the temperature is increased, the carbides become coarser and lose their effectiveness as a source of strength. In contrast, slow cooling from the high temperature range promotes grain boundary precipitation of carbides. Further precipitation of grain boundary carbides occurs during subsequent exposure to elevated temperatures. Continuous networks of grain boundary carbides, however, are undesirable because they embrittle the alloy and promote intergranular cracking.
